O.N. Fitting Work Execution Instructions

Construction of Nice Joint	(1) Operation type: Pipe cutting	(2) Operation type: Pipe deburring	(3) Operation type: Attachment setup	(4) Operation type: Pipe insertion

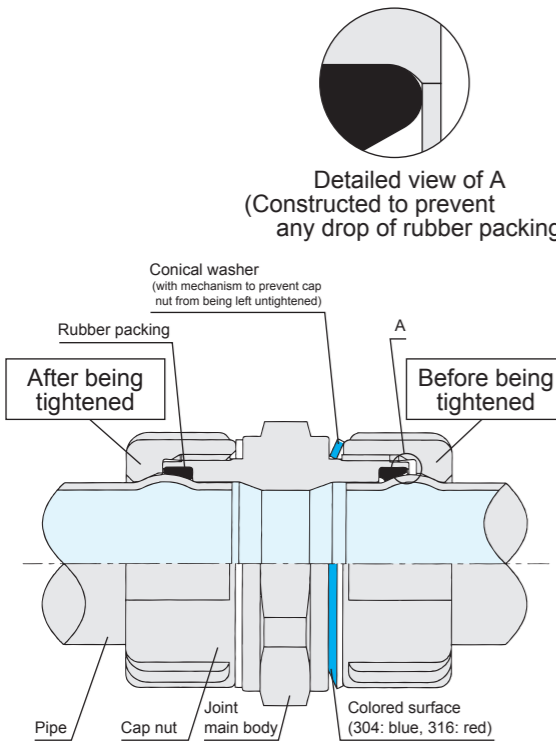
<p>Detailed view of A (Constructed to prevent any drop of rubber packing)</p> <p>Conical washer (with mechanism to prevent cap nut from being left untightened)</p> <p>Rubber packing</p> <p>After being tightened</p> <p>Before being tightened</p> <p>Pipe</p> <p>Cap nut</p> <p>Joint main body</p> <p>Colored surface (304: blue, 316: red)</p>	<p>○ = stainless steel pipe cutting machine 122J-S, band saw, metal saw, or chip saw used</p> <p>Stainless steel pipe cutting machine 122J-S</p> <p>* The system causes no outer burr. (Equipped with inner surface reamer intended for inner burrs)</p>

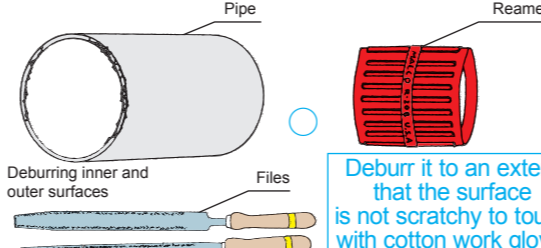
<p>Deburring inner and outer surfaces</p> <p>Files</p> <p>Reamer</p> <p>Deburr it to an extent that the surface is not scratchy to touch with cotton work glove.</p> <p>× = If the deburring is insufficient: Outer burr: Rubber packing will be damaged, causing leakage. Inner burr: Causes scratch on the pipe enlargement rubber.</p>

<p>○ = Use a round file, half round file and/or reamer.</p>

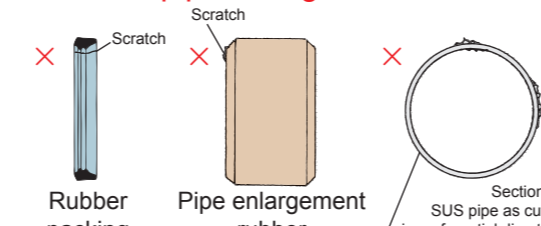
<p>Scratch</p> <p>Rubber packing</p> <p>Pipe enlargement rubber</p> <p>Section of SUS pipe as cut in circumferential direction</p>	<p>○ = Use spanner and screwdriver contained in the toolbox.</p> <p>Hand tightening alone is unacceptable!! Tighten it securely.</p>

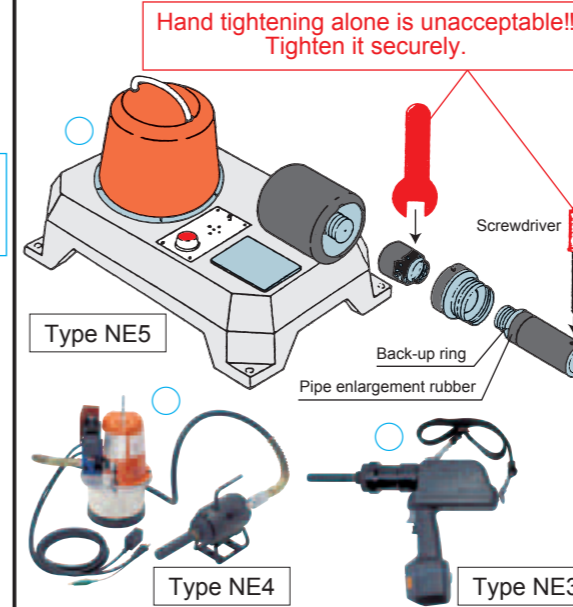
<p>Type NE5</p> <p>Type NE4</p> <p>Type NE3</p> <p>Back-up ring</p> <p>Pipe enlargement rubber</p> <p>Screwdriver</p> <p>× = Hand tightening will make the pipe enlargement defective.</p>	<p>○ = Insert the pipe all the way until it hits. Hand-tighten the cap nut as far as it goes.</p>

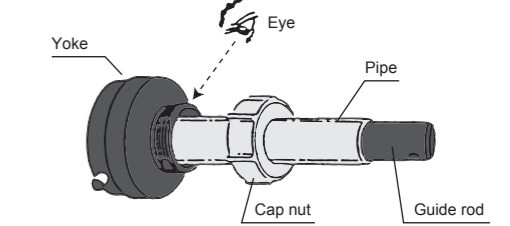
<p>Yoke</p> <p>Eye</p> <p>Pipe</p> <p>Cap nut</p> <p>Guide rod</p> <p>× = Any insufficient insertion may cause a bend in piping and/or leakage. Insufficient hand-tightening of nut may cause defective pipe enlargement, resulting in leakage.</p>

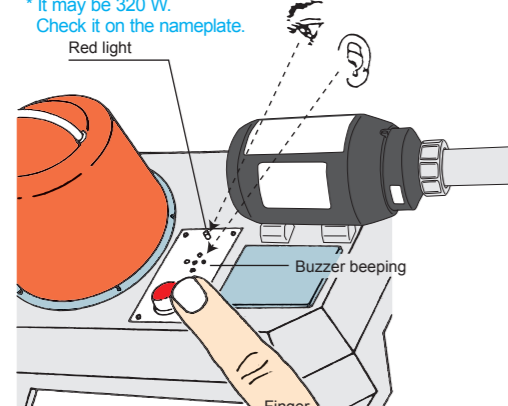
<p>(5) Operation type: Pipe enlargement</p> <p>○ = Type NE5 Once the buzzer beeps and light illuminates, take your finger off the button. Motor capacity = 400 W, power supply 100 VAC * It may be 320 W. Check it on the nameplate.</p>

<p>Red light</p> <p>Buzzer beeping</p> <p>Finger</p> <p>○ = Type NE4 Keep the button pressed for 2-3 seconds after a change in the hydraulic sound.</p> <p>○ = Type NE3 Once you hear a sound "click, click, click," take your finger off the button and press the return switch.</p> <p>× = If the button is released on the way, it will cause an insufficient pipe enlargement, potentially causing leakage.</p>	<p>(6) Operation type: Enlarged section measurement</p> <p>○ = Pass if the enlarged section stops on the No-go side.</p> <p>(1) Conduct the inspection when replacing the attachment.</p> <p>(2) Conduct it once for every 50 times.</p> <p>Pipe enlargement rubber is consumable (with service life of about 400 times).</p>

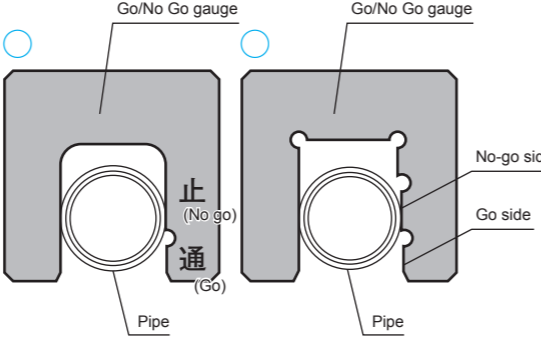
<p>Go/No Go gauge</p> <p>Go/No Go gauge</p> <p>No-go side</p> <p>Go side</p> <p>○ = Fail if the enlarged section passes on the No-go side, because it may cause leakage. Replace the pipe enlargement rubber. Re-inspect the tightening of the tool.</p>	<p>(7) Operation type: Rubber packing direction</p> <p>○ = Fitting onto the joint main body</p> <p>The rubber packing will not drop since the joint is constructed to prevent the packing from dropping. However, be careful of the direction of the packing when replacing it.</p>

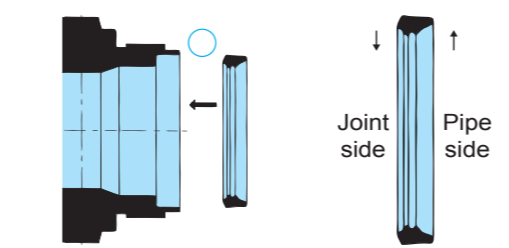
<p>Joint side</p> <p>Pipe side</p> <p>× = If fitted in reversed direction, the packing will decrease in the service life, potentially resulting in leakage. If the packing is inserted as fitted onto the pipe, it may be pinched, potentially causing leakage.</p>

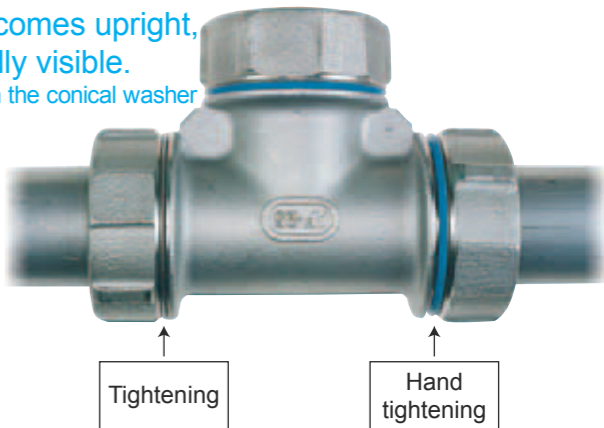
<p>Tightening</p> <p>Hand tightening</p>

<p>(8) Operation type: Cap nut tightening (equipped with a mechanism to prevent cap nut from being left untightened)</p> <p>○ = Tighten until the conical washer becomes upright, and the blue color will become hardly visible. (When the cap nut is tightened, the gap between the conical washer and the joint main body is 0.1 mm maximum.)</p> <p>1. Any insufficient tightening will cause a gap between the cap nut and the end surface of the joint, which will, under any heat applied to the joint, cause the rubber packing to expand and escape to the gap between the cap nut and the joint end surface from the packing box, eventually causing leakage.</p> <p>2. When adjusting the angle of the joint or the valve, do it after the tightening. Rotating the pipe with the nut hand-tightened or insufficiently tightened will twist the rubber packing, potentially causing leakage that cannot be detected by the pressure test.</p> <p>× = Insufficient tightening causes leakage.</p>

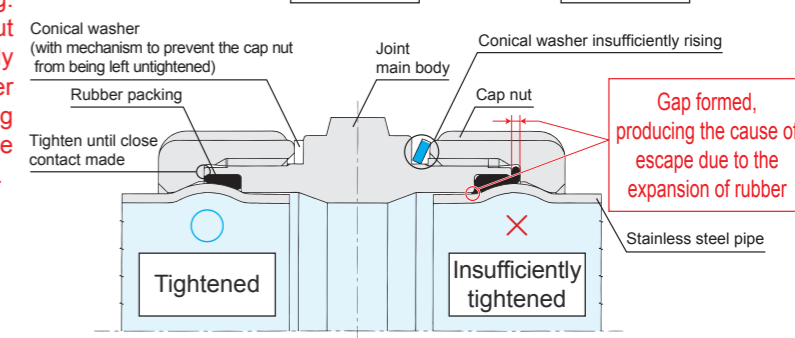
<p>Conical washer (with mechanism to prevent the cap nut from being left untightened)</p> <p>Rubber packing</p> <p>Joint main body</p> <p>Cap nut</p> <p>Conical washer insufficiently rising</p> <p>Gap formed, producing the cause of escape due to the expansion of rubber</p> <p>Tightened</p> <p>Insufficiently tightened</p> <p>Stainless steel pipe</p> <p>Tighten until close contact made</p>
